Special Report 84-26

Cold Regions Research &
Engineering Laboratory

Secondary stress within the structural frame of DYE-3: 1978-1983

H. Ueda, W. Tobiasson, D. Fisk, D. Keller and C. Korhonen

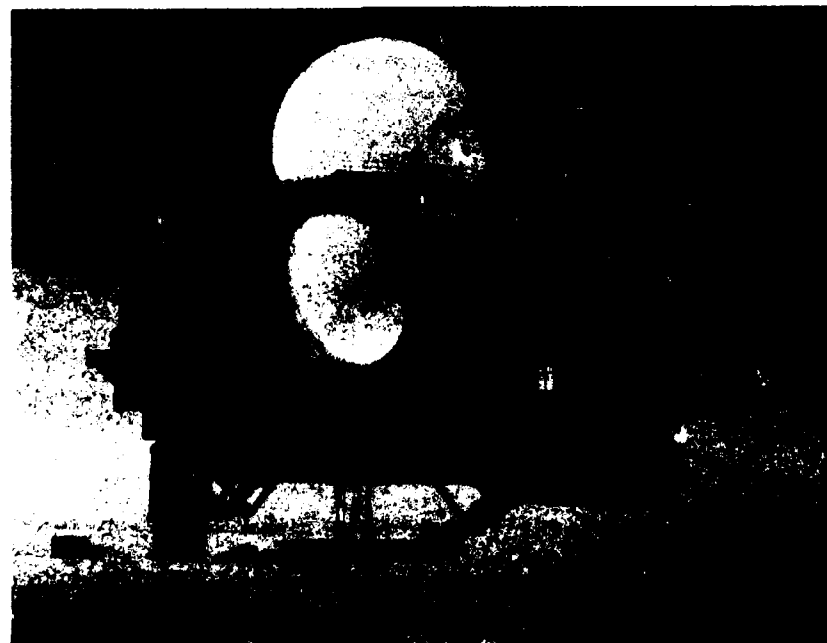
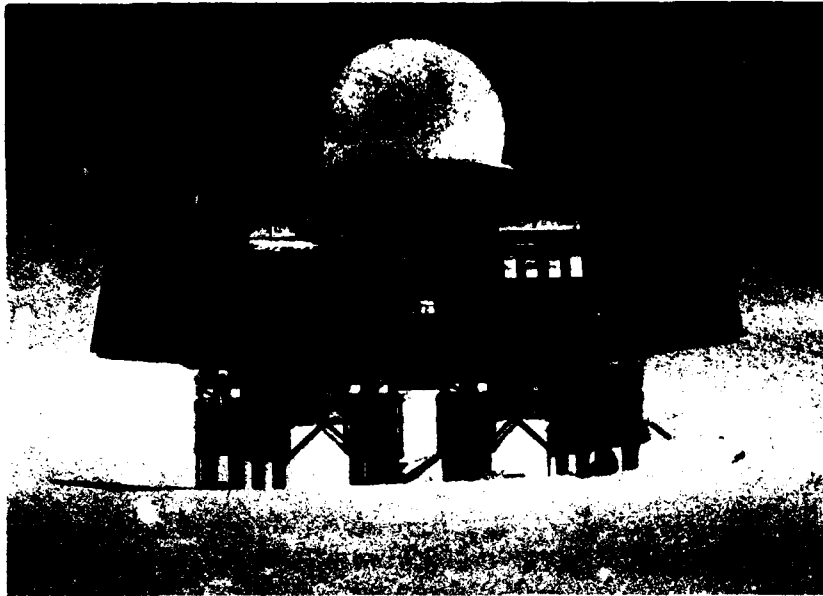
a. From the southeast.

Figure 2. Exterior views of DYE-3 (1981).

b. From the southwest.

*All are in the A to N direction (see Fig. 2b).

**All are in the column 4 to column 1 direction (see Fig. 2b).

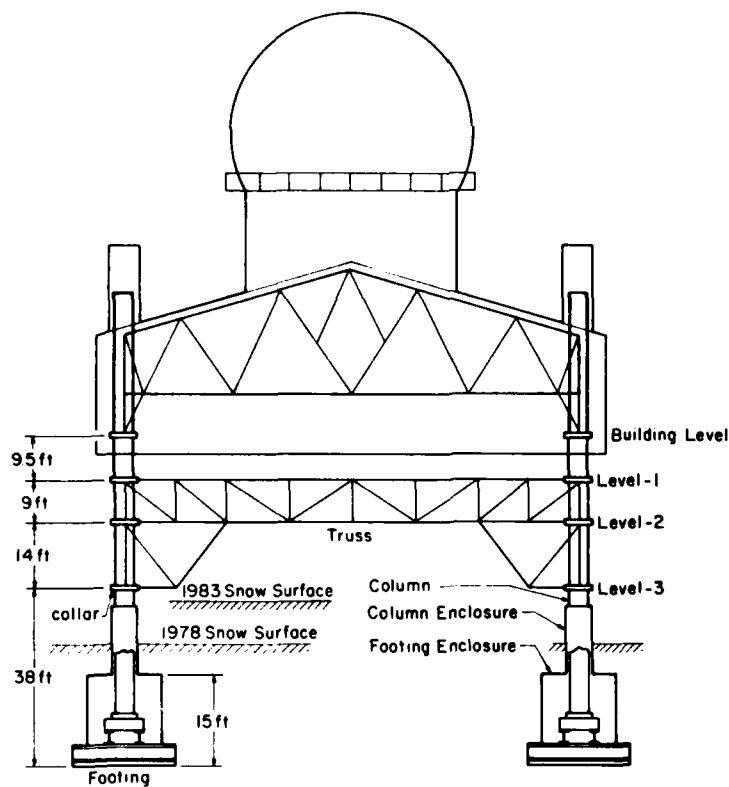
a. Elevation cross section.

Figure 3. DYE-3 structural system.

Figure 1 shows the location of DYE-3 in Greenland. Exterior views of DYE-3 are shown in Figure 2; elevation and plan views of the DYE-3 structural system are shown in Figure 3. A detail of the trusses and collars at column N1 is shown in Figure 4. The 2600-ton building is supported by eight columns and can be leveled and raised by hydraulic lifts located at each column on the second floor where the building hangs from 6-in.-diameter threaded rods. The two 80-ton truss networks are independent of the building. They rest on

in Figure 3a. The sway bolts located on the first floor of the building are also arranged as shown in Figure 6.

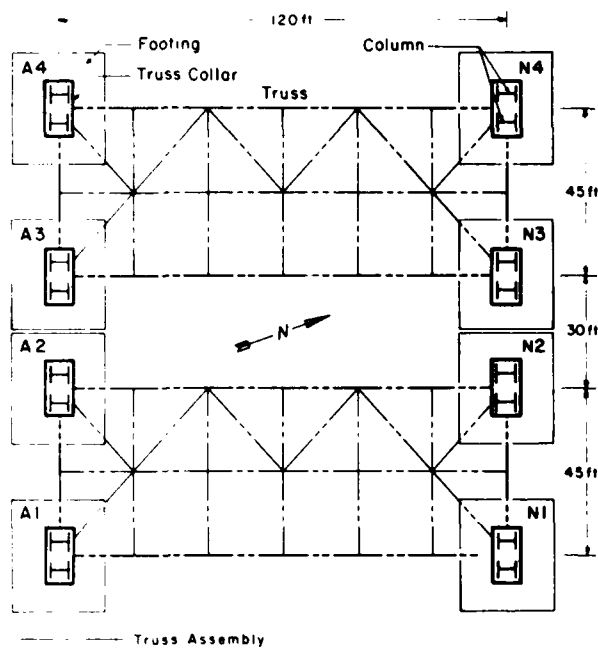
b. Plan view showing footing, column and truss layout.

Figure 3 (cont'd). DYE-3 structural system.

Free-body diagrams of each column and the connecting trusses are presented in Appendix B. The free-body diagrams of the trusses assume simple, two-dimensional plane configurations. In reality the connecting trusses form two three-dimensional truss assemblies (Fig. 3b), each of which encompasses four columns.

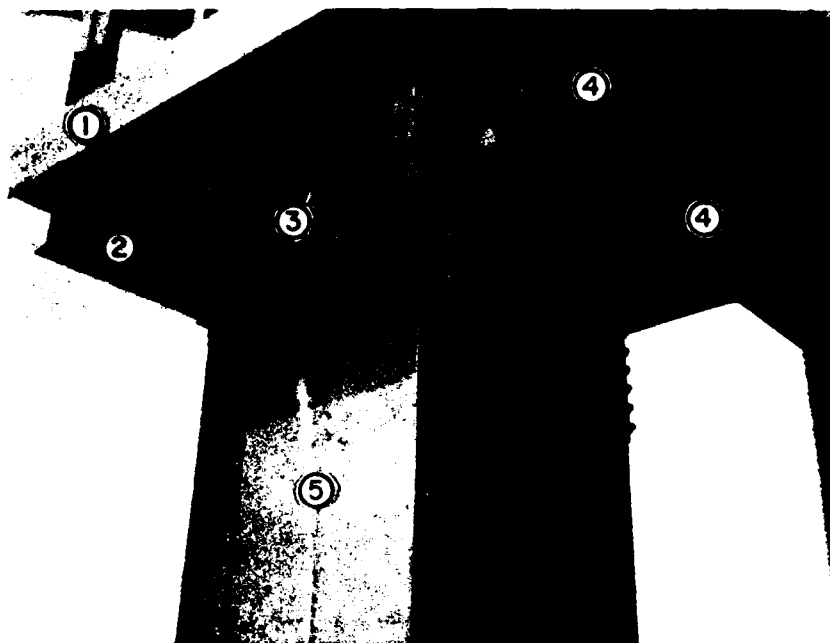
Figure 5. Truss support points and collar assembly (1 - collar, 2 - channel that supports truss, 3 - sway bolt [1 of 12 at each collar], 4 - beams that support truss, 5 - column half).

steel beams and channels attached to the columns (Fig. 5). To permit periodic lifting and leveling of the trusses, they are not connected to the columns in a conventional manner; instead, a rectangular collar surrounds the column at each connection point and sway bolts (Fig. 5) that act as set screws transmit lateral loads between the collar and the column.

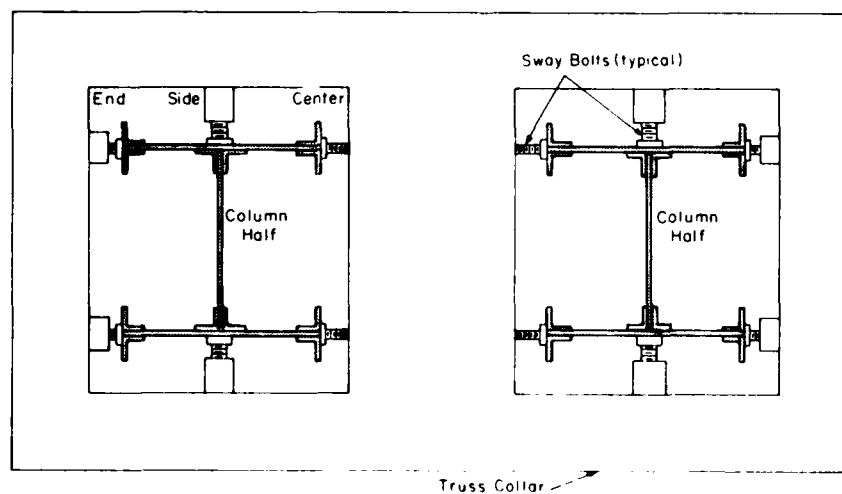
Figure 6. Plan view of typical truss collar and column showing the 12 sway bolts.

There are 12 large sway bolts at each collar (Fig. 6) and there are three collars at each column. They are designated levels 1, 2 and 3 as shown

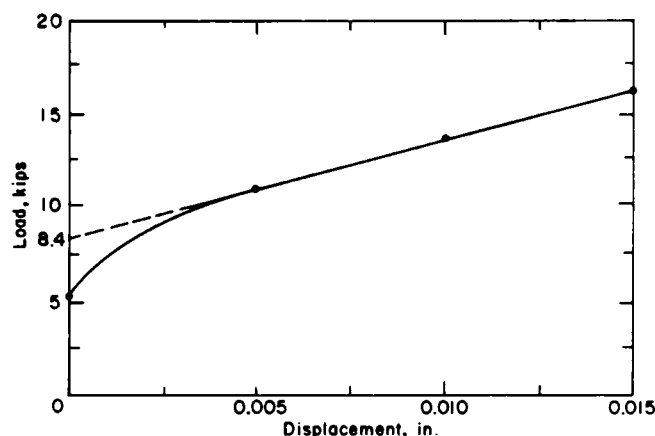
Figure 11. Typical load-displacement curve for a sway bolt that could not be backed off.

In 1978, 13 sway bolts could not be backed off because of interfering bolt or rivet heads that made it impossible to turn them, and their loads had to be determined using a load-displacement technique (Tobiasson and Ueda 1974). The technique consists of measuring the load at various displacements and using the plot of this relationship to estimate the zero

displacement load. A typical determination is shown in Figure 11. In that example, the sway bolt load is considered to be 8.4 kips. In 1981, all of the interferences were successfully removed, thereby simplifying the measurement process considerably and increasing measurement accuracy.

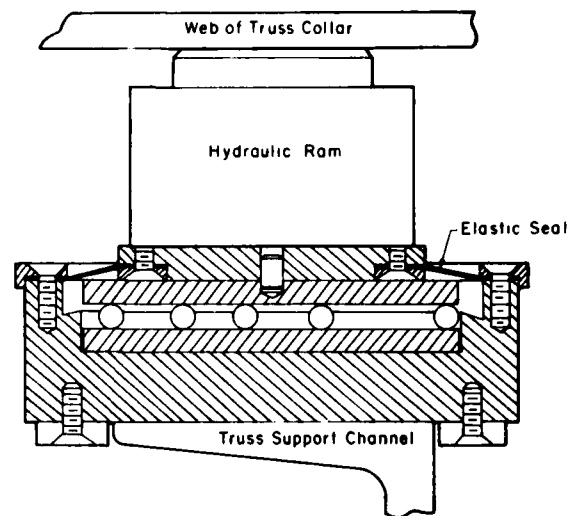
Figure 12. Cross section of friction-reducing roller devices.

In 1981, an attempt was made to reduce friction there during sway bolt readings by supporting the four corners of each level-3 collar on friction-reducing roller devices (Fig. 12 and 13) designed by Ueda and Tobiasson. Unfortunately, the center portion of each level-3 collar, which rests on two beams (Fig. 5), did not lift when the rollers were inserted at the four cor-

ners because of high flexibility in the collar assembly; therefore, considerable frictional resistance was still present between the column halves.

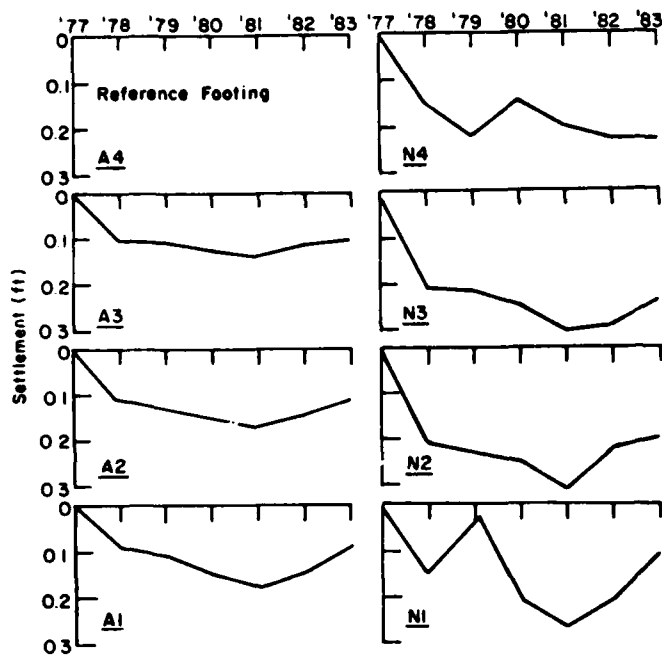
Figure 14. Footing settlements relative to footing A4, 1977-83.

Secondary stresses are accumulating in the DYE-3 structural frame because of differential settlement and tilt of the footings, and horizontal distortion of the footing system by lateral flow of the ice cap. Horizontal distortion was measured some years ago at DYE-3 (Flax et al. 1971). Differential settlements and footing tilts measured since the sideways move in 1977 are presented in Figures 14 and 15 respectively.

The settlement of DYE-3 relative to the bedrock over a mile below is not known, but it probably amounts to a few feet per year. Absolute settlement of this sort is of no particular concern but differential settlement among the eight footings certainly is. In a highly indeterminate structure such as this, differential settlements can induce significant secondary stresses in the structure frame. The settlements presented in Figure 14 are referenced to footing A4 since it has settled less than the other seven footings.

The largest differential settlements occurred just after the building was moved. During the past 5 years, differential settlement among the footings has reached 0.3 ft. When assessing the impact of differential settlement, it is important to consider the distance between footings. For example, the 0.12 ft differential between footings A3 and A4, which are only 45 ft apart, may induce greater secondary stresses on the A2-A3 truss and the building frame in that area than the 0.23 ft differential between footings A4 and N4, which are 120 ft apart. When the building and trusses are raised in 1984, they will be releveled which, in principle at least, removes all secondary stresses in the frame caused by differential settlement and tilt of the footings.

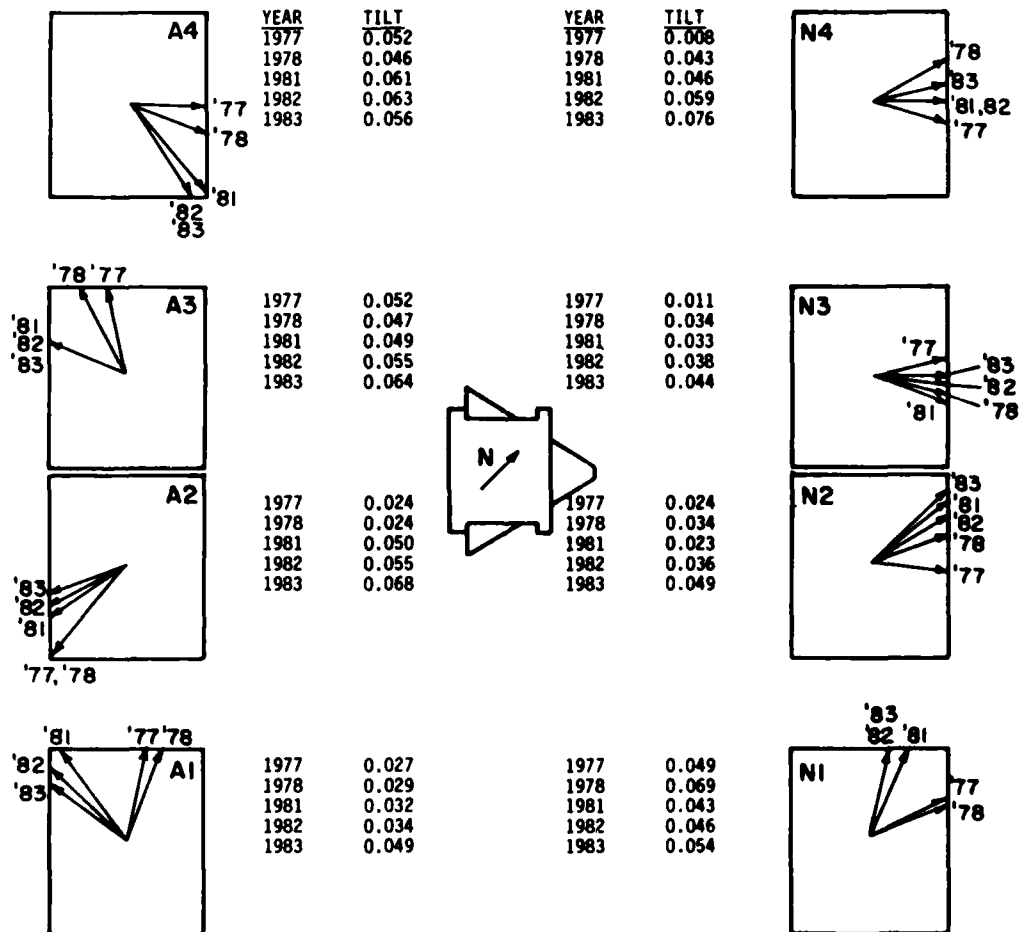
Figure 15. Footing tilts, 1978-83 (in./ft). Arrows indicate downward tilt directions.

Footing tilt measurements are summarized in Figure 15. For some footings, 1983 tilt is about the same as the initial "built-in" tilt. Footings A3, A4 and N1 fall into this category. The tilt of the other footings has increased over the past 5 years.

Do bending stresses in the columns cause the footings to tilt or do the tilting footings cause bending stresses in the columns? If bending stresses caused the footings to tilt, their tilt would increase over the years in the direction of the bending. Since this is not generally the case, it appears that the tilting footings are inducing bending stresses in the columns and other stresses in the trusses and the building frame. The snow surface under the building is lower than the surface surrounding the building. The extra overburden pressure surrounding the building tends to cause the footings to tilt away from the center of the building. In addition, strength and density differences of the snow on which the footings are founded causes them to tilt. That snow is far from homogeneous since it has been pushed around and built up by operations in that area since 1959.

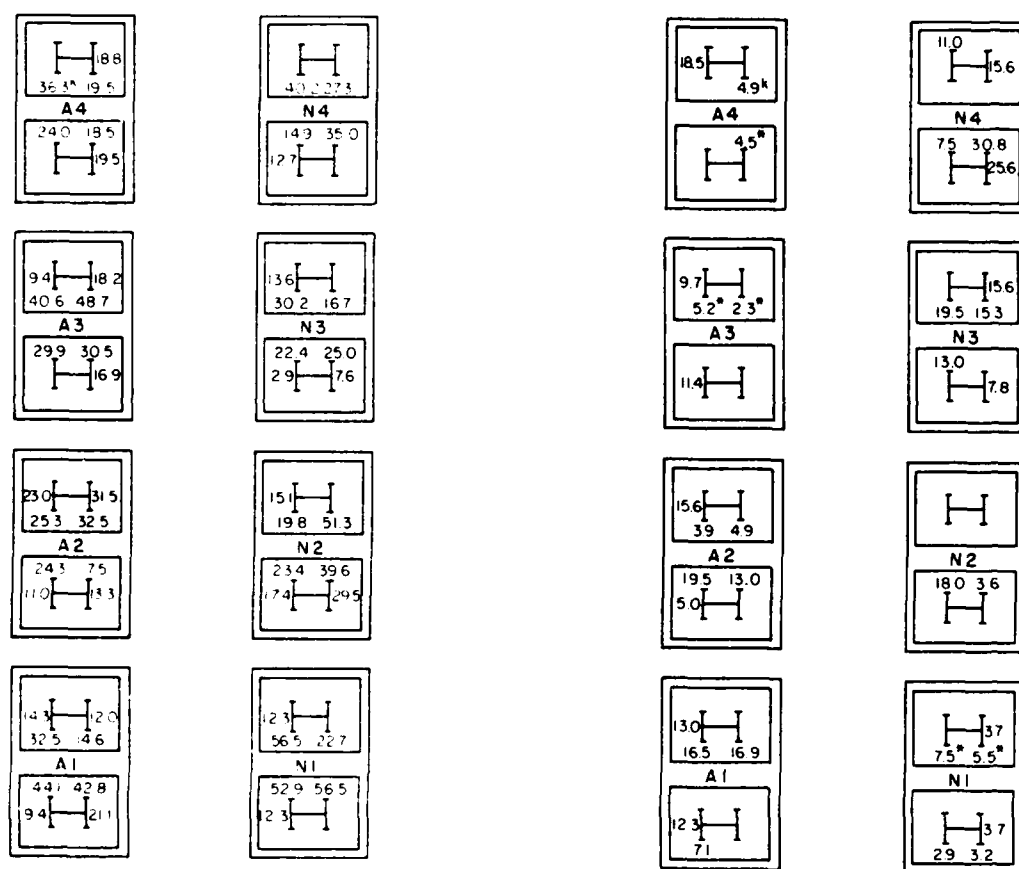
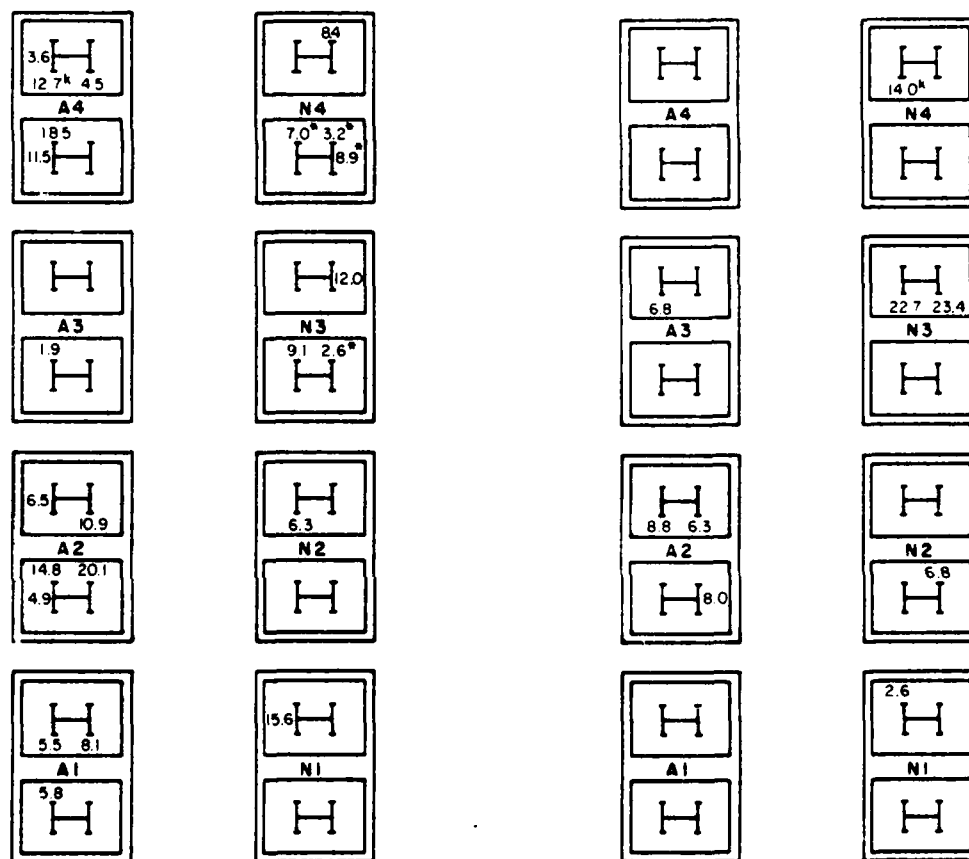
Figure A1. Individual sway bolt load measurements (in kips [1000 lb], * = load displacement measurement).

Figure A1 (cont'd). Individual sway bolt load measurements (in kips [1000 lb], * = load displacement measurement).

Sway bolt measurements taken in 1978, 1981, 1982 and 1983 as well as column bending moments determined from these measurements are presented in

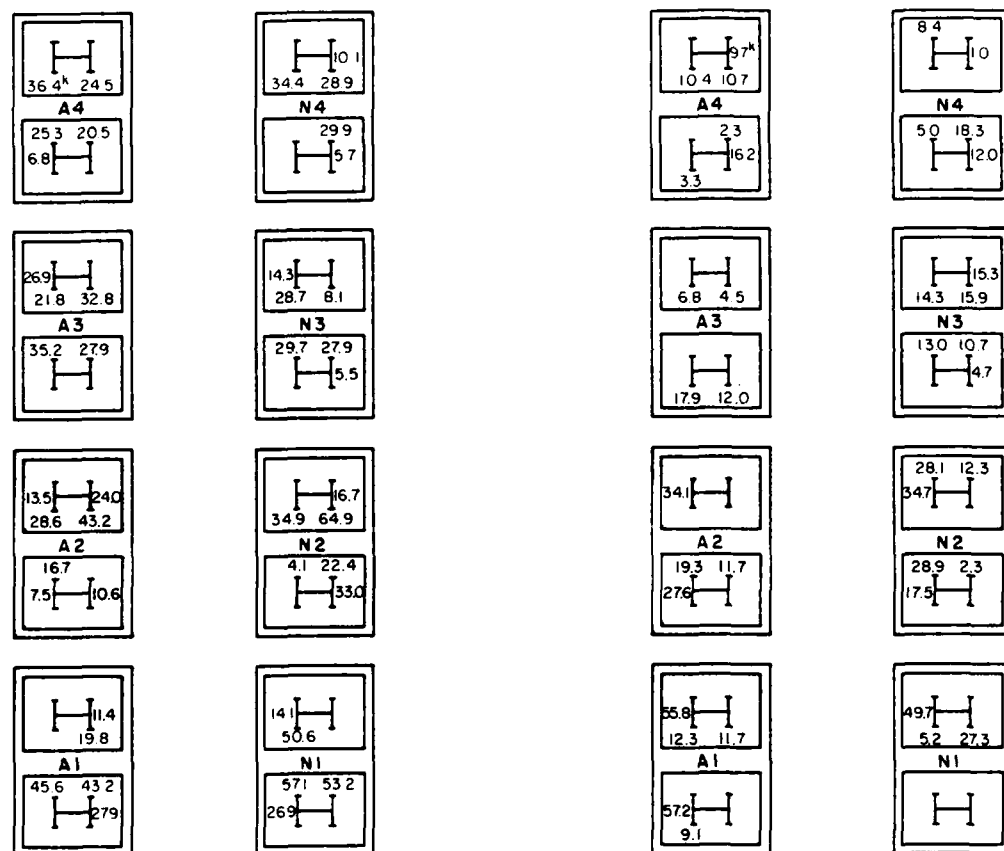
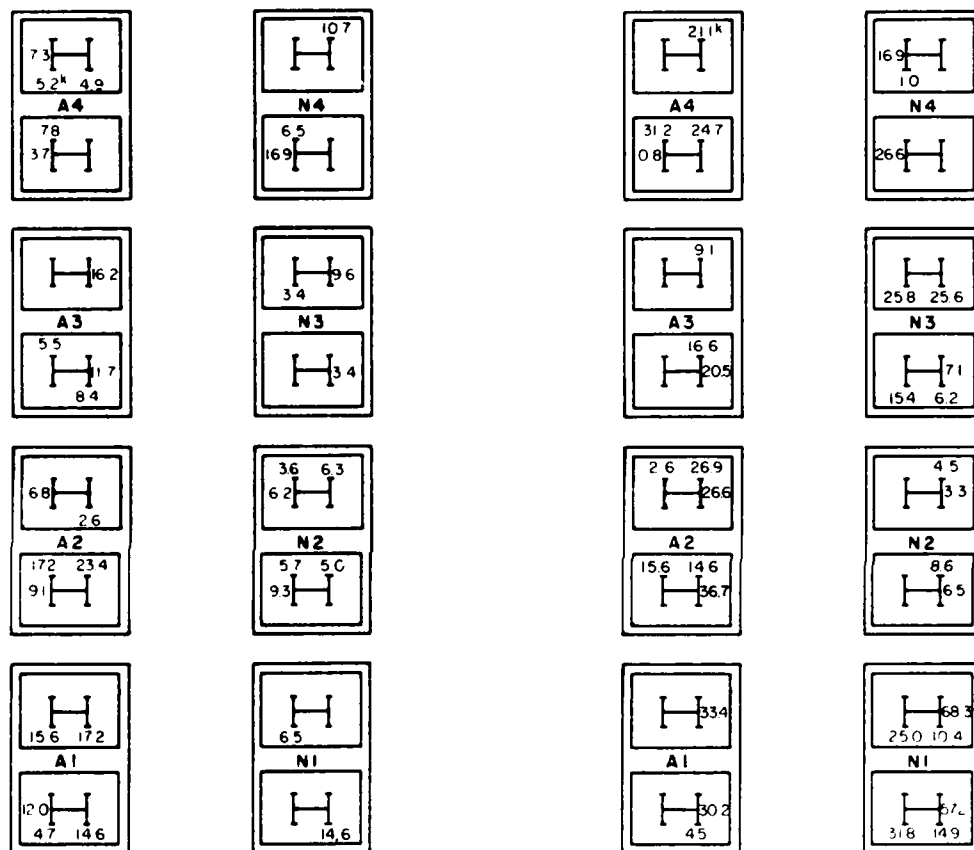
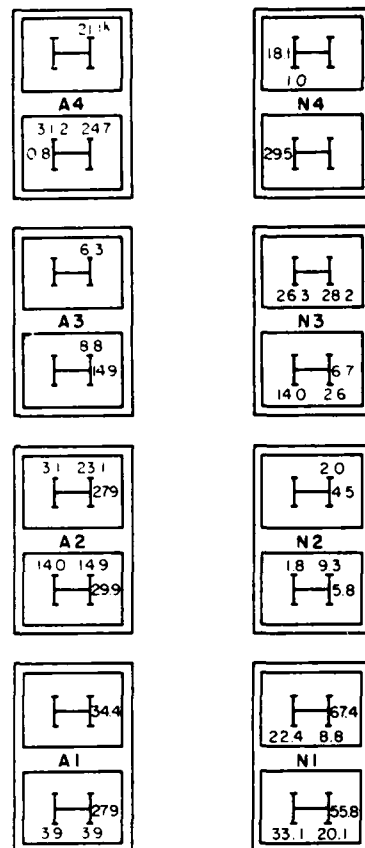
a. Building level. b. Level 1.

Figure A2. Individual sway bolt load measurements (in kips [1000 lb]).

Figure A2 (cont'd). Individual sway bolt load measurements (in kips [1000 lb]).

e. Level 3, without friction-reducing devices.

Two sets of level-3 sway bolt readings are presented in Appendix A, 1981 Measurements, one with and one without the rollers installed. The rollers did not change level-3 sway bolt loads much. An unsuccessful attempt was made in 1982 to insert Teflon sheets between all bearing surfaces of the level-3 collars, but again the center portion of the collars could not be lifted. Consequently, loads measured on the level-3 collars are only a rough indication of the actual loads there. Level-1 and level-2 collar loads were measured more accurately. When the building and trusses are raised in 1984, low-friction bearing surfaces will be provided for the truss system. Teflon and stainless steel sheets will be inserted between the contact surfaces at these points, using a design developed cooperatively

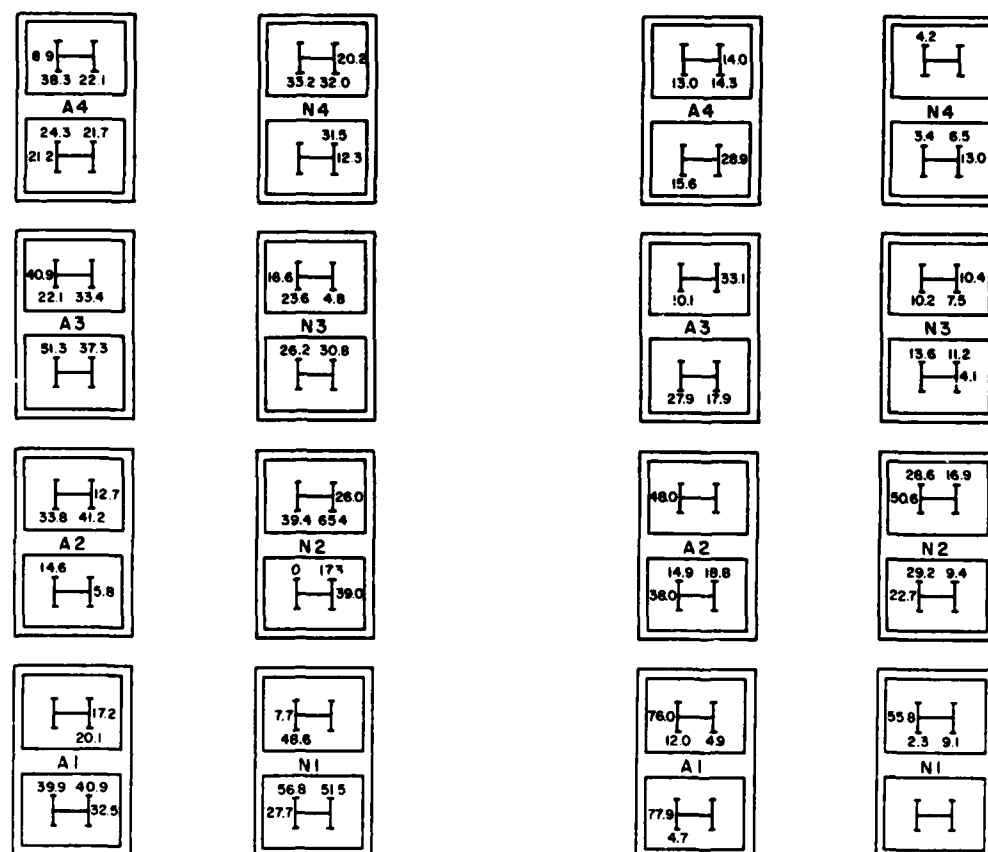
a. Building level. b. Level 1.

Figure A3. Individual sway bolt load measurements (in kips [1000 lb]).

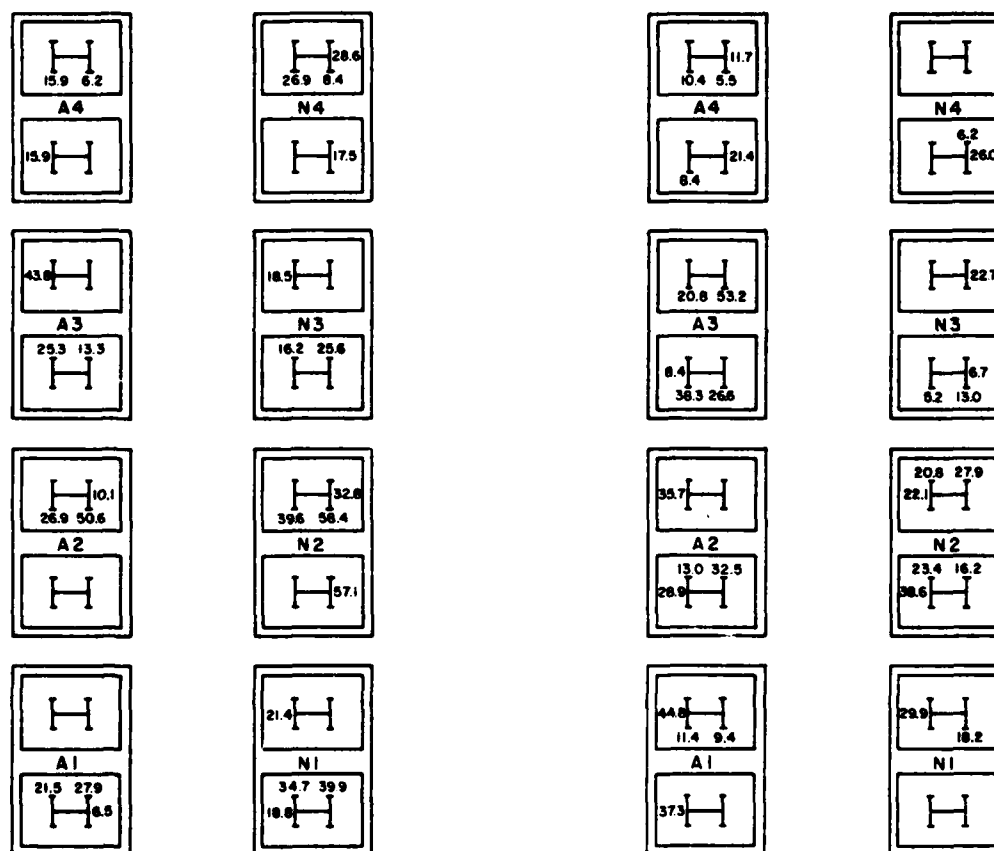
1983 Measurements

a. Building level.

b. Level 1.

High pinching and spreading loads (i.e., loads on a column at a collar in opposing directions) existed at the building level in 1978 (see, for example, sway bolt loads at column A2, building level, in Figure A1a). This condition usually occurs between column halves. Pinching and spreading loads were also present in 1981 and 1982. In 1983 all of the pinching loads were eliminated prior to load measurements.

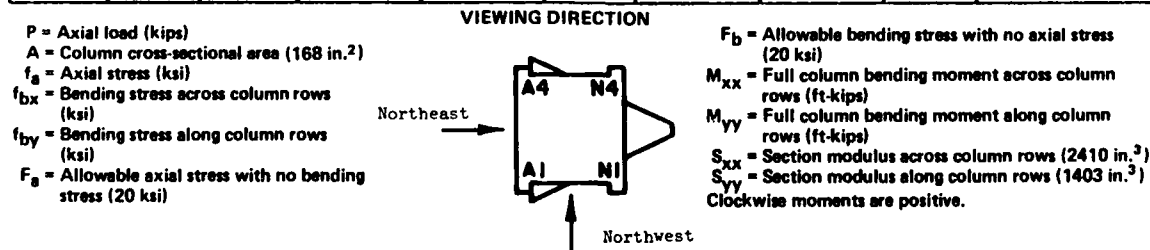
APPENDIX B: FREE-BODY DIAGRAMS FOR COLUMNS AND CONNECTING TRUSSES.

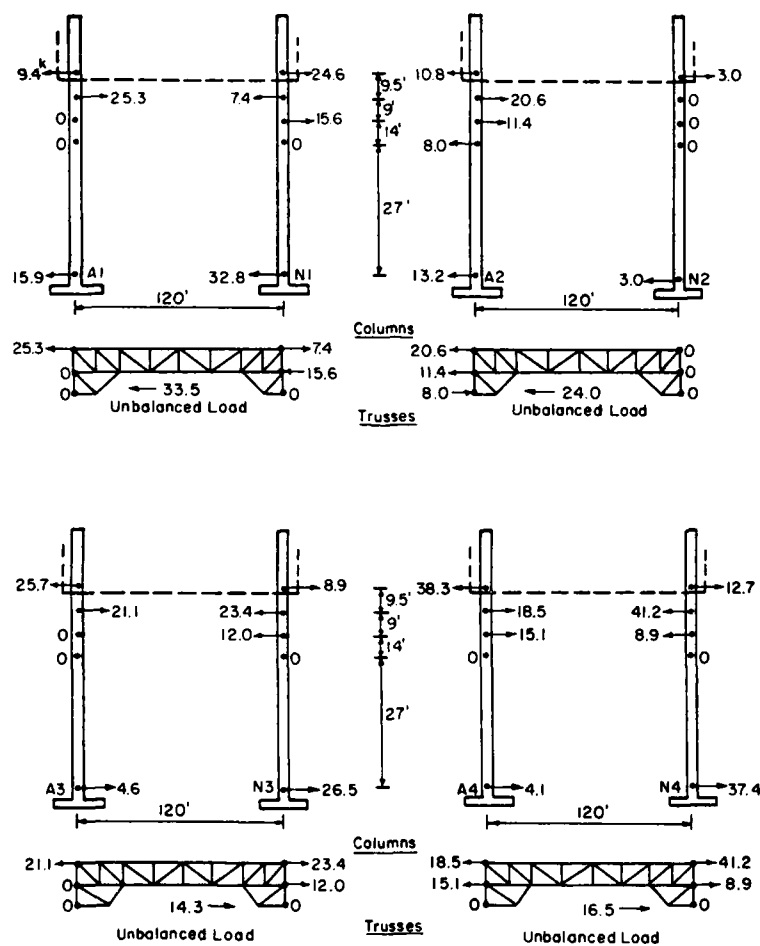
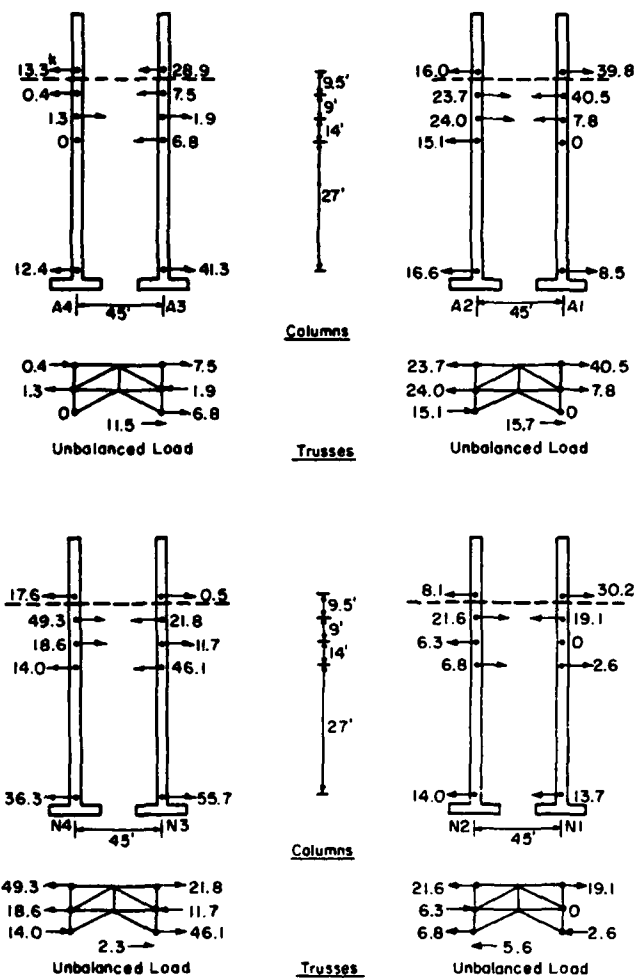
Figure B1. 1978.

Figure B1 (cont'd). 1978.

Friction problems notwithstanding, there was a significant increase and change in direction of some of the collar loads from 1978 to 1981 (compare Fig. B1 and B2). We anticipated changes because the 1978 measurements were made immediately after the building had been raised and many of the lateral loads then should have been relatively low. However, the magnitude of some

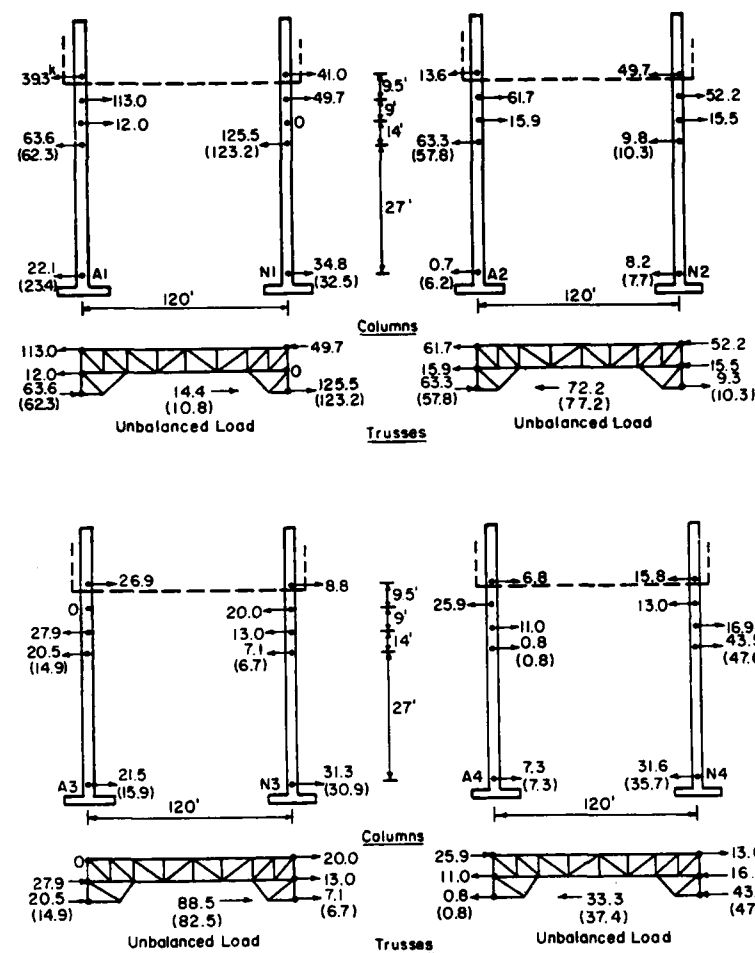
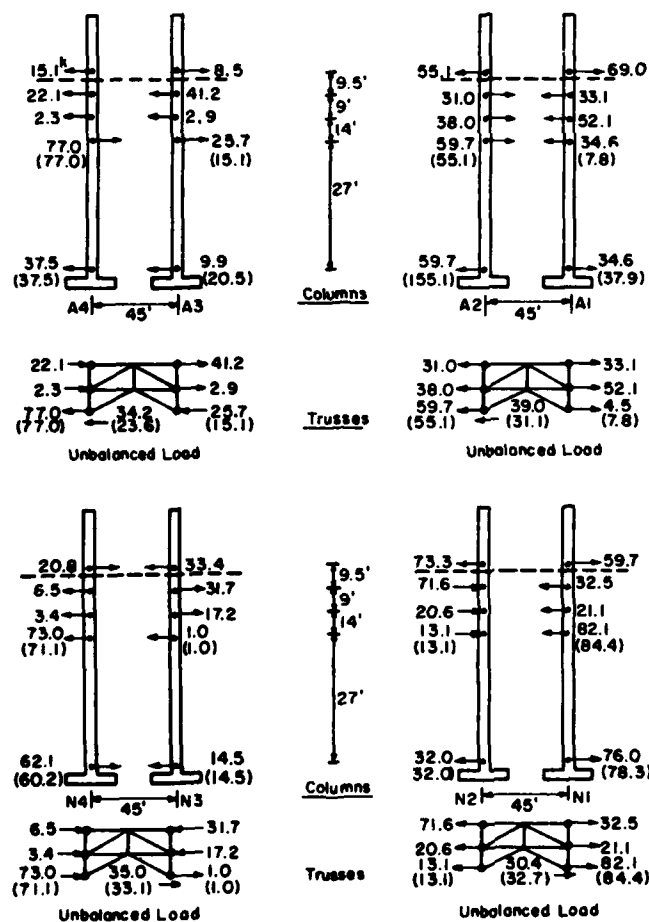
Figure B2. 1981 (values in parentheses were measured without friction-reducing devices).

Figure B2 (cont'd). 1981 (values in parentheses were measured without friction-reducing devices).

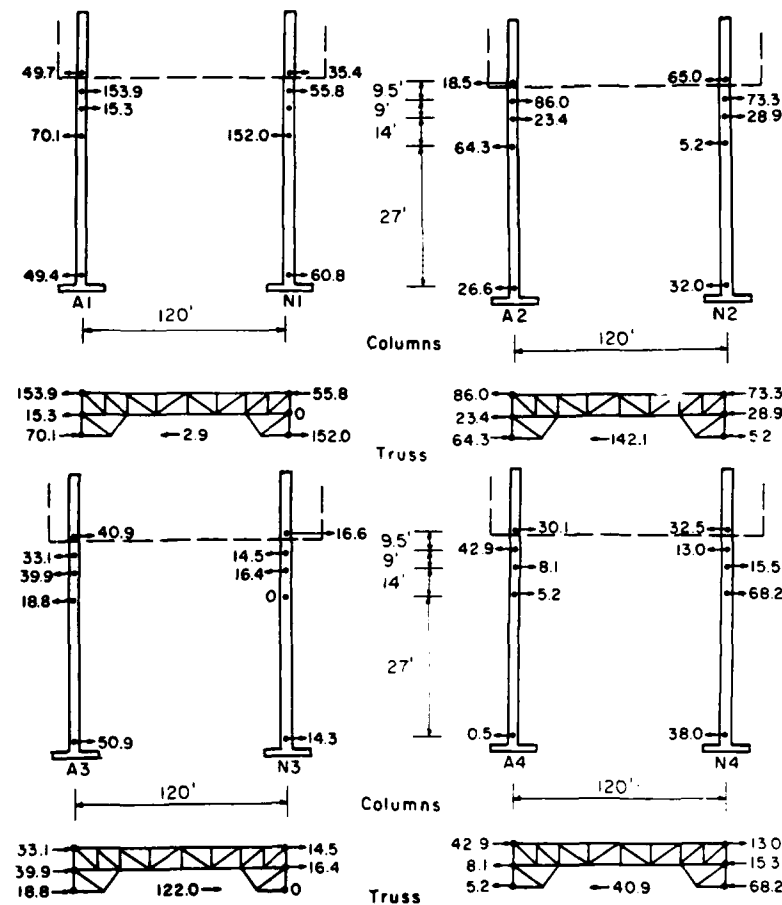
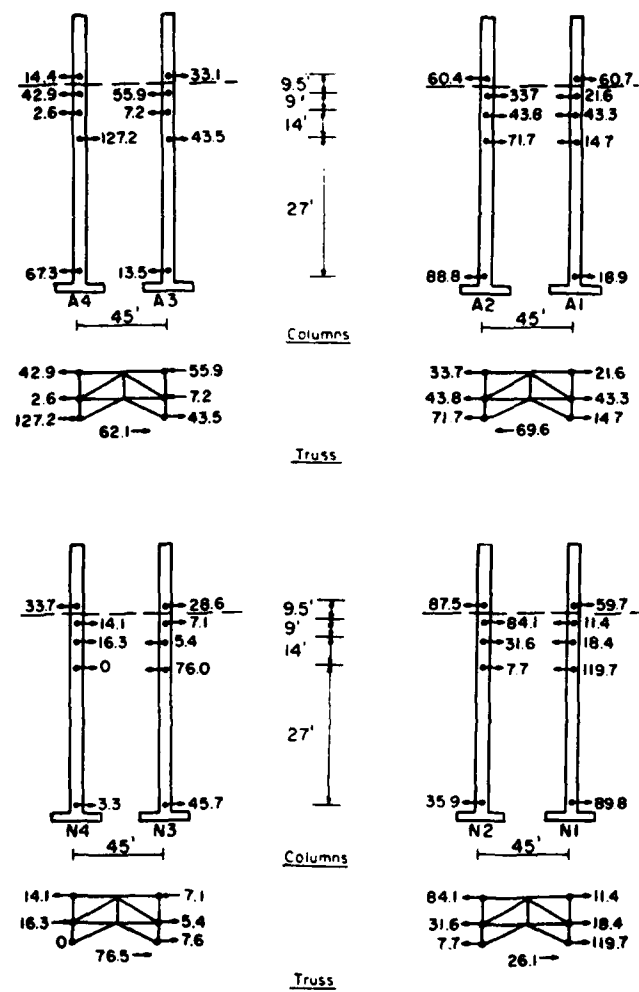
Figure B3. 1982.

Figure B3 (cont'd). 1982.

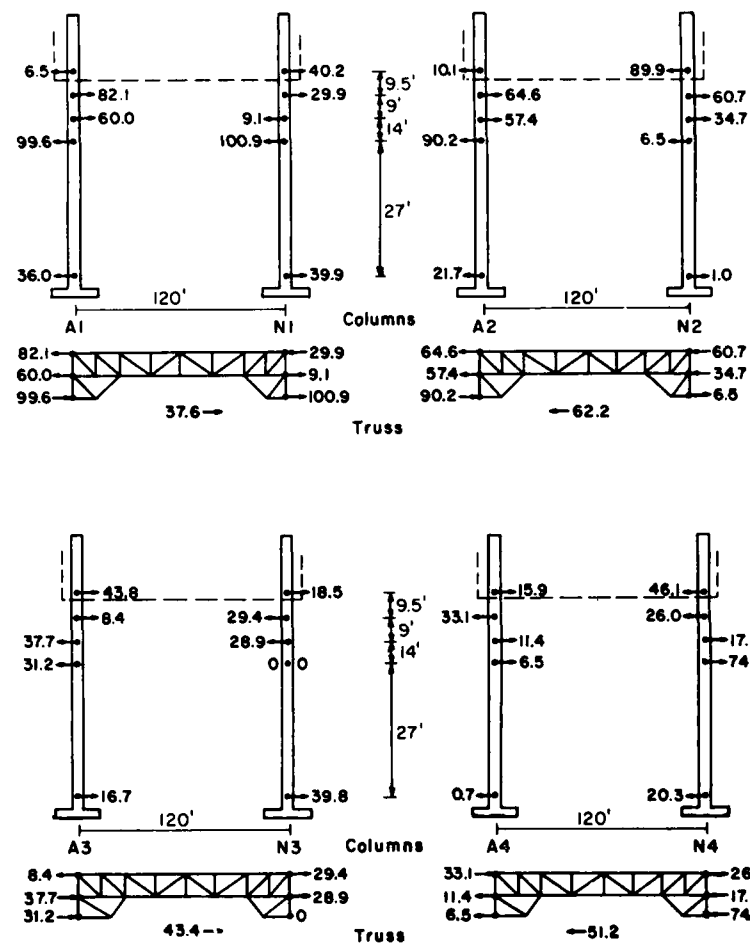
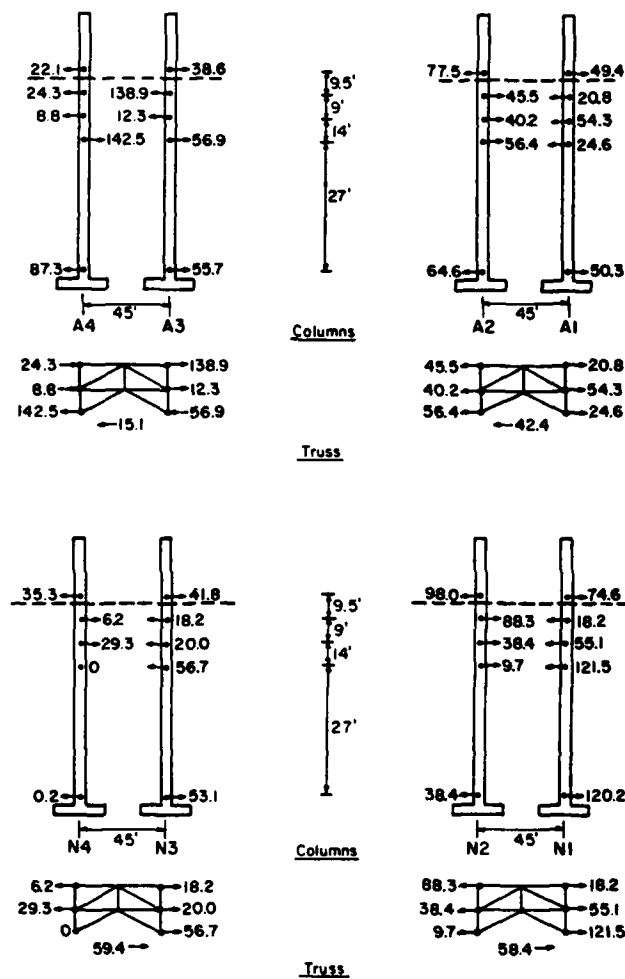
Figure B4. 1983.

Figure B4 (cont'd). 1983.
